## 6.3 ARCHITECTURAL COMPONENTS

### 6.3.2 INTERIOR PARTITIONS

#### 6.3.2.1 INTERIOR PARTITION WALLS, HEAVY

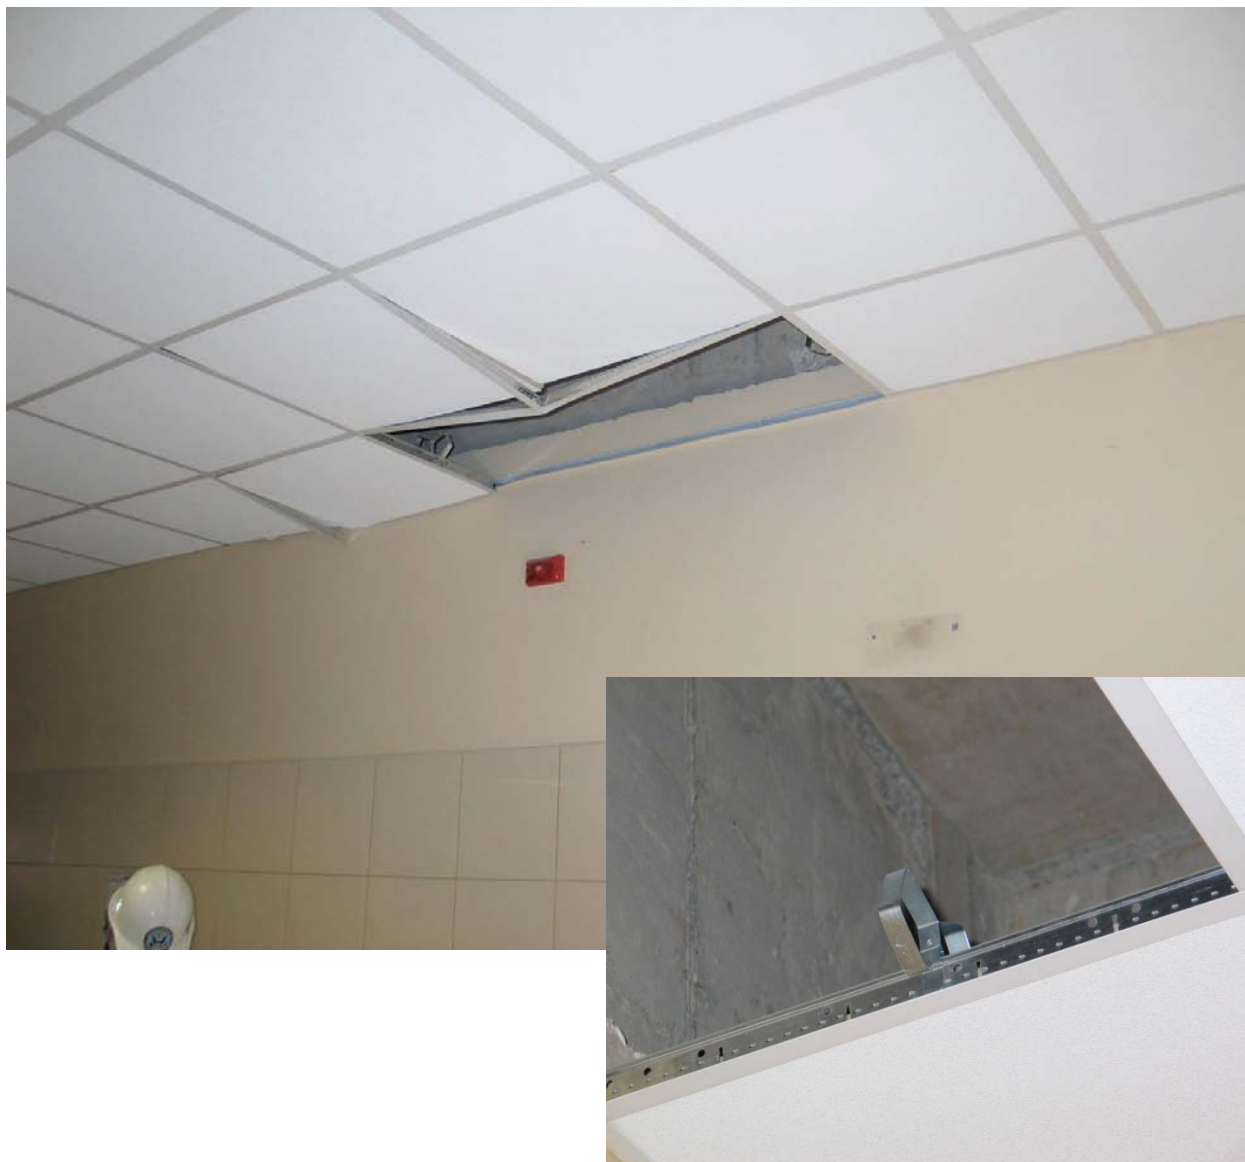
Figure 6.3.4.1-4      Fallen ceiling tiles at Talca Hospital in the 2010 Chile Earthquake, in spite of the use of clips as shown in detail at right. Most ceilings observed in Chile did not have seismic detailing (Photos courtesy of Bill Holmes, Rutherford & Chekene).

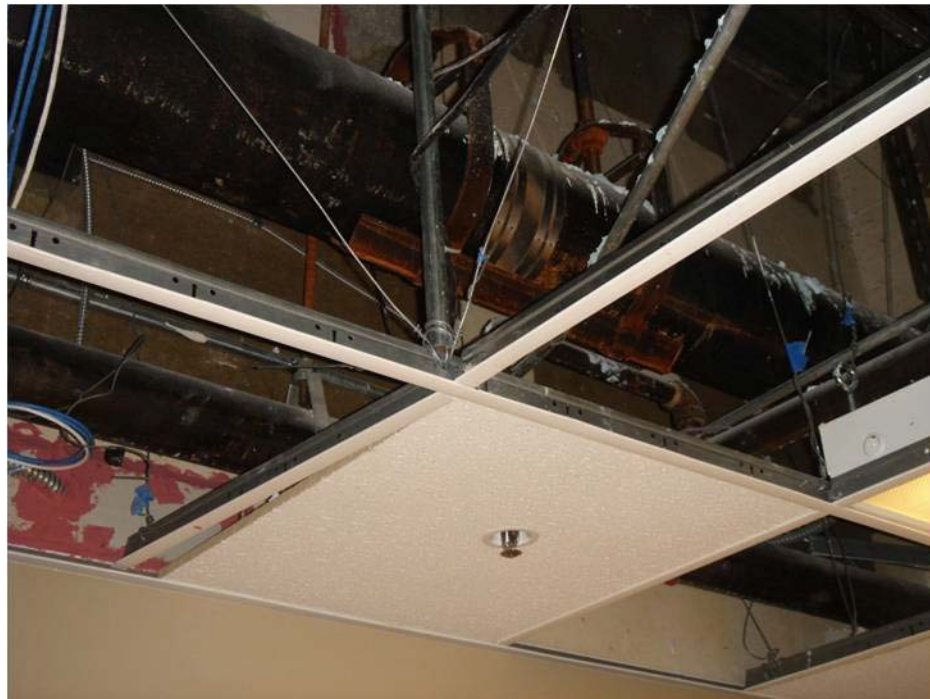
Figure 6.3.4.1-5 Compression struts and diagonal splayed wires are used to limit the movement of suspended acoustic tile ceilings. Per ASTM E580, this type of bracing assembly is required for ceiling areas larger than 1000 sq. ft. in Seismic Design Category D,E & F. (Photo courtesy of Maryann Phipps, Estructure).

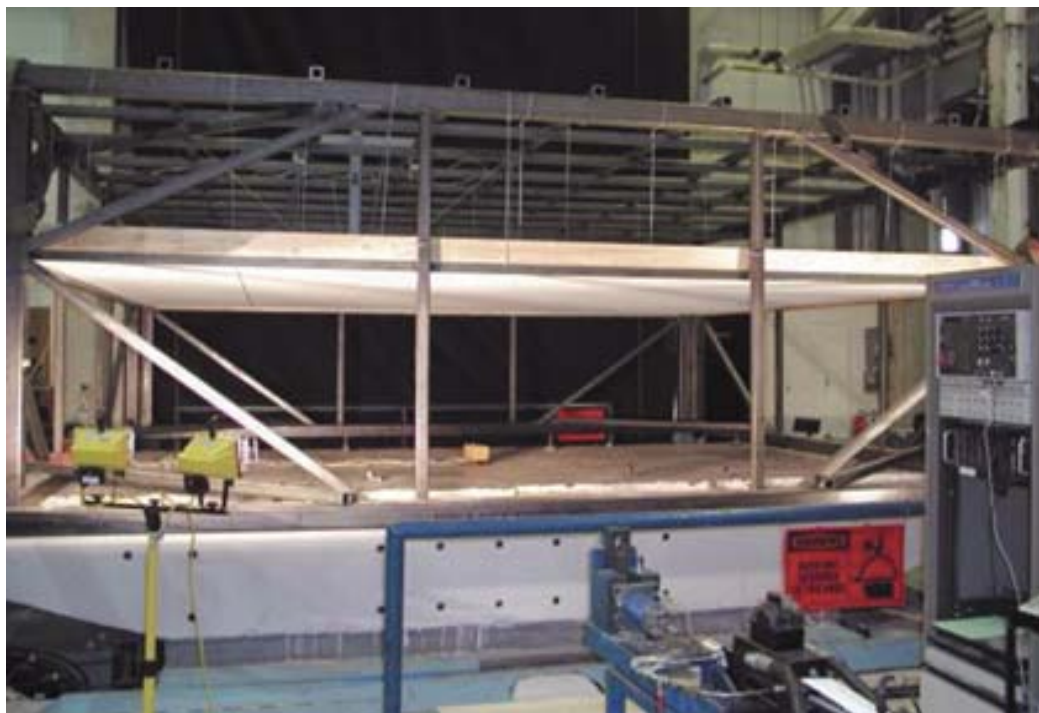
Figure 6.3.4.1-6 Shake table testing of a proprietary suspended acoustic lay-in tile ceiling at MCEER (Photo courtesy of University of Buffalo, SUNY). Additional testing of these systems will help improve our understanding of their failure modes and help inform the design of more resilient systems.

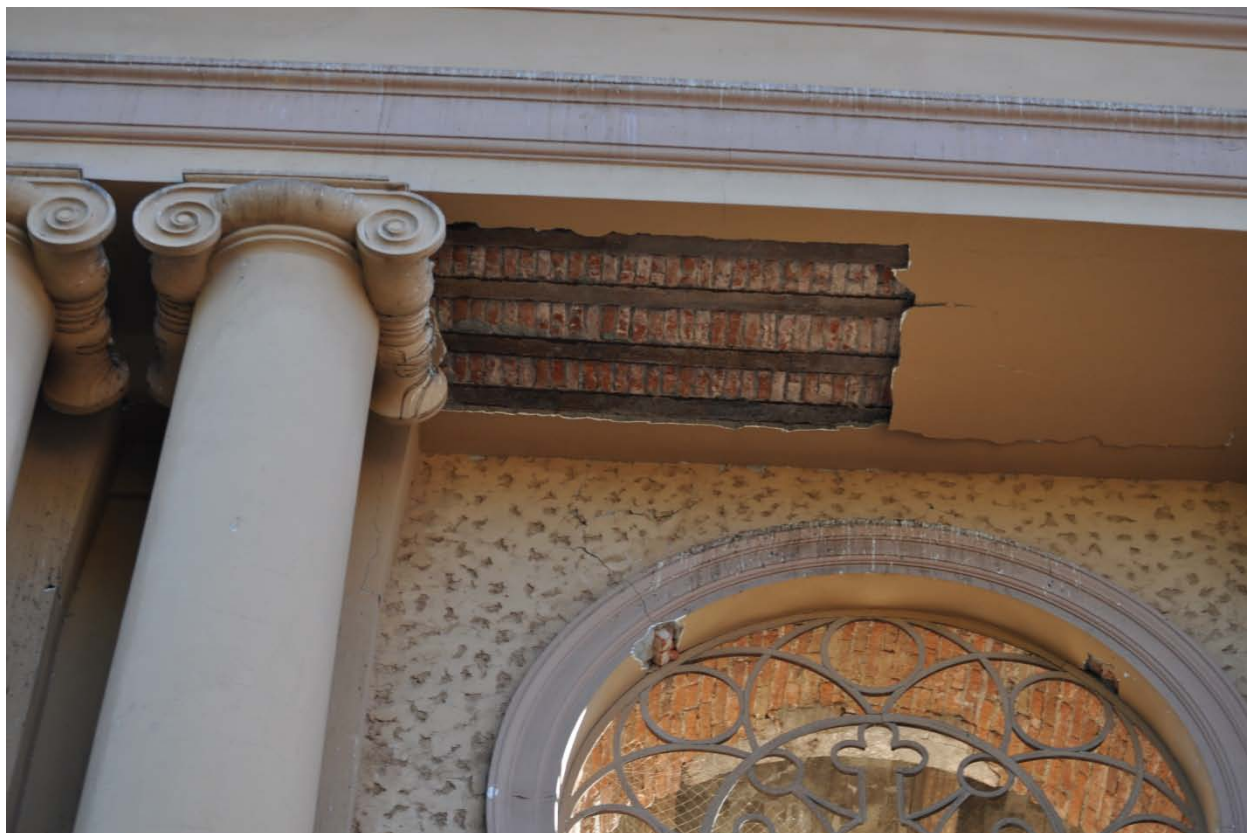
Figure 6.3.4.2-2

Damage to stucco soffit of historic church in the 2010 Chile Earthquake (Photo courtesy of Eduardo Fierro, BFP Engineers). Stucco applied directly to the underside of the slab above without furring; portion at left has fallen, portion at right delaminated.

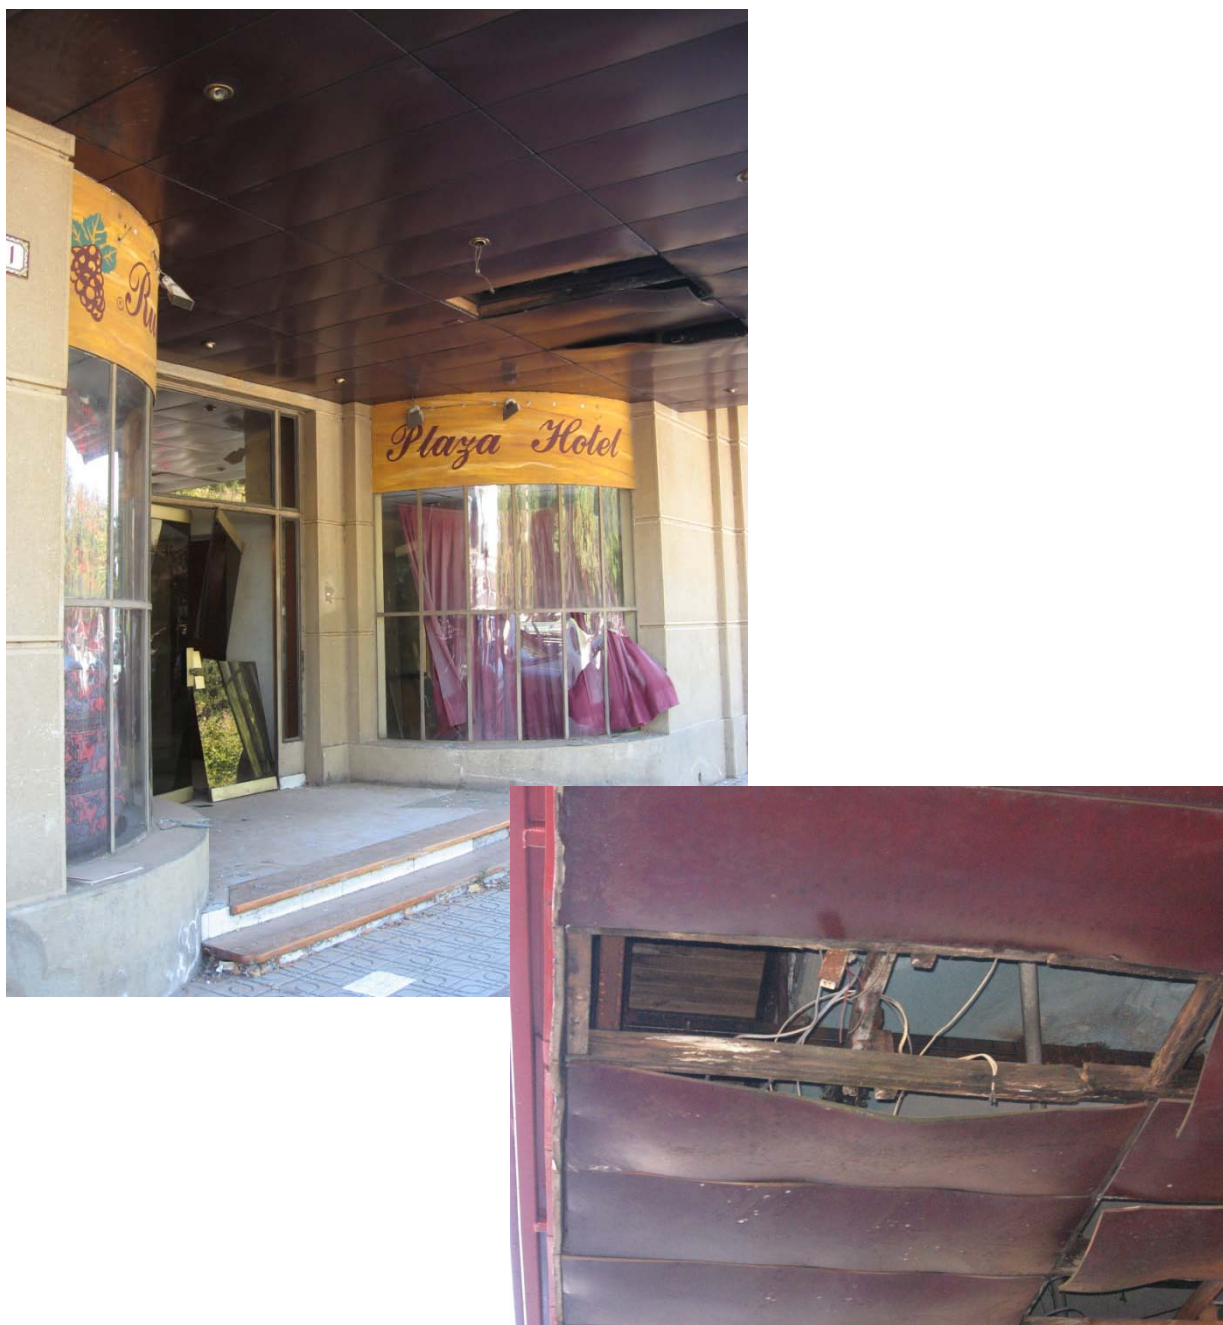
Figure 6.3.4.2-3

Damage to soffit paneling and wood framing at hotel in the 2010 Chile Earthquake; panels and wood framing show signs of prior water damage and deterioration. Note also damage to storefront glazing and glass doors (Photos courtesy of Rodrigo Retamales, Rubén Boroschek & Associates).

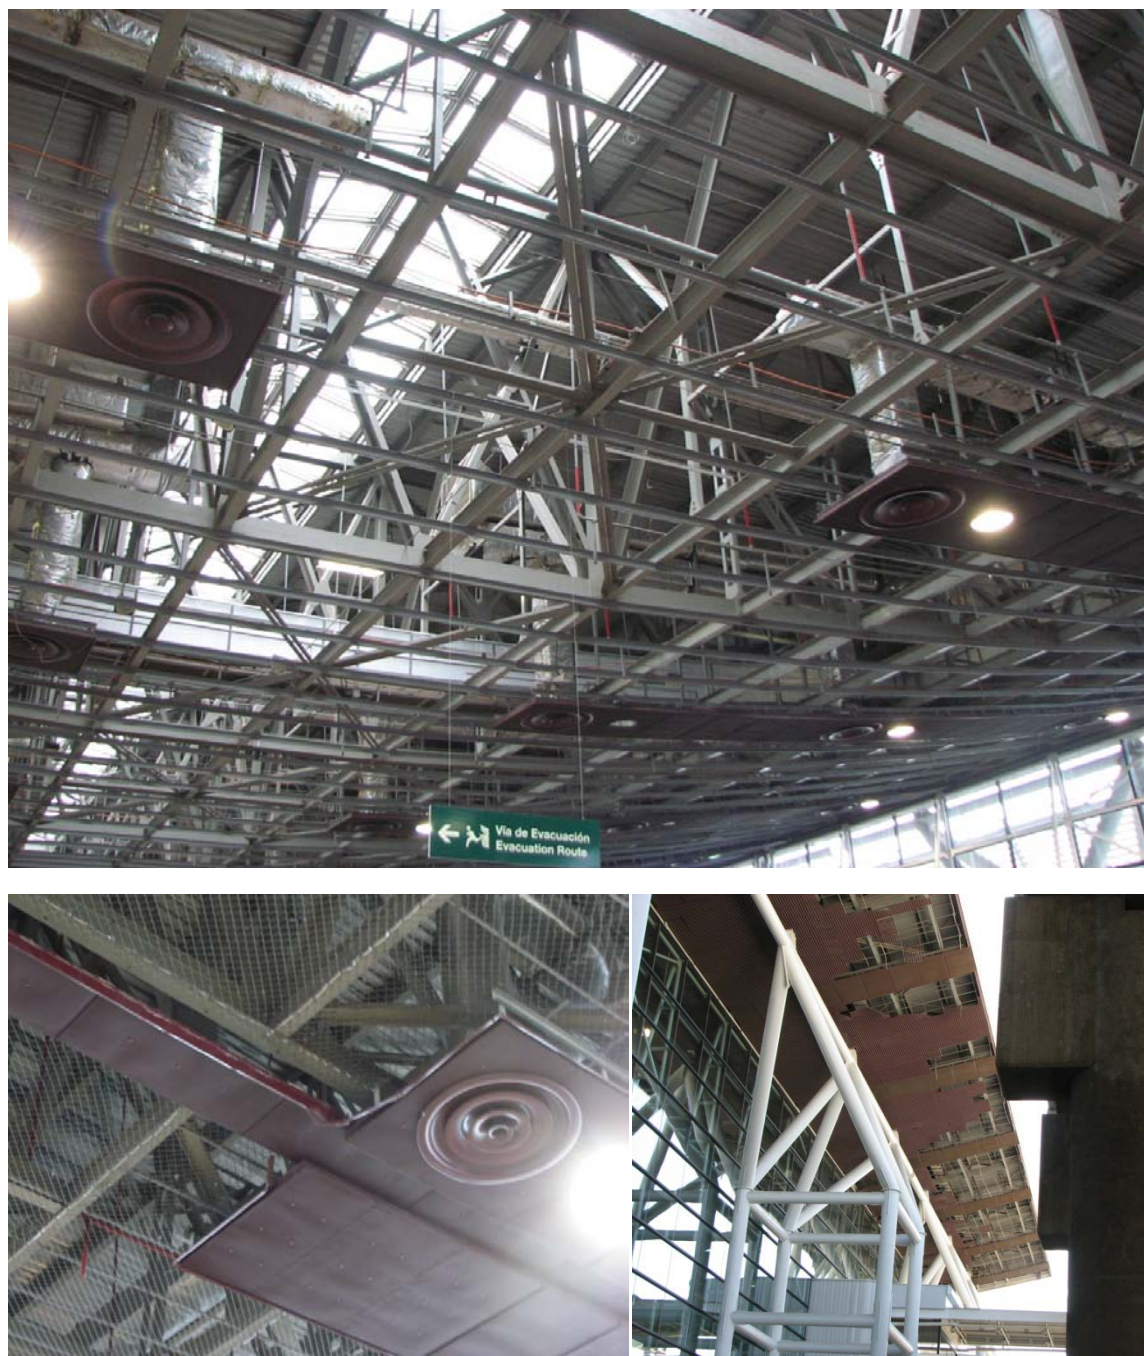
Figure 6.3.4.2-5

Extensive failure of ceiling in the main terminal of the Santiago airport in the 2010 Chile Earthquake. Metal panels with lights and diffusers hung from furring on short metal tabs; these remained in place but detail at lower left shows they also sustained some damage. Furring channels still in place throughout ceiling but majority of lightweight ceiling panels and much of the cross furring came down as shown at lower right photo of exterior soffit with same system (Photos courtesy of Antonio Iruretagoyena, Rubén Boroscchek & Associates).

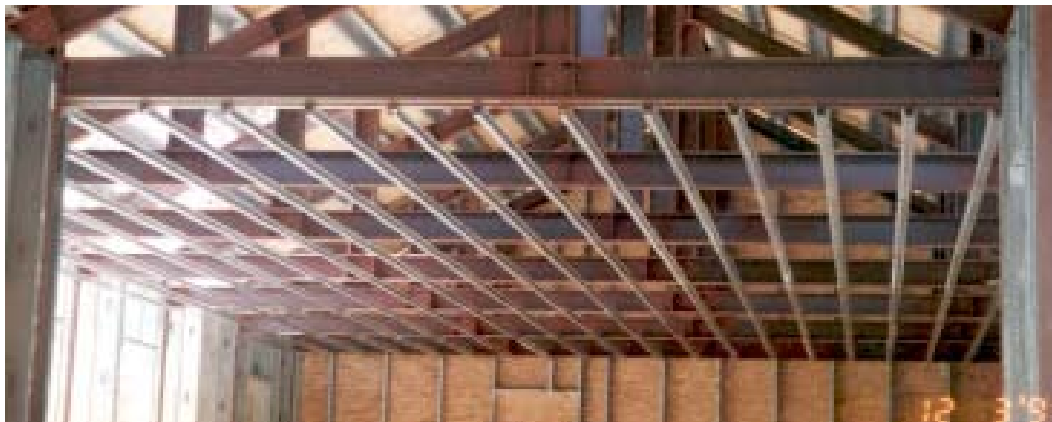
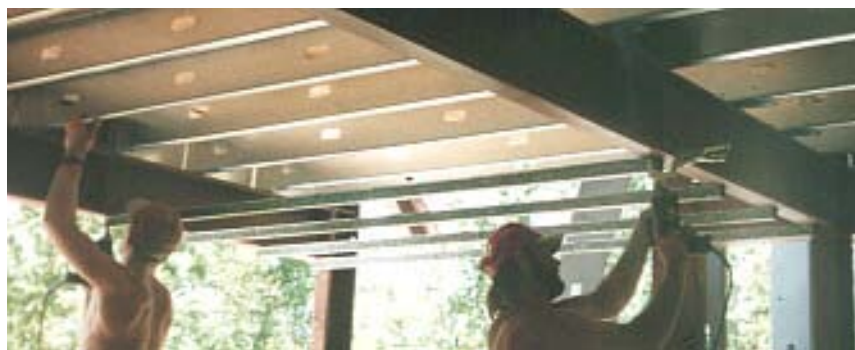
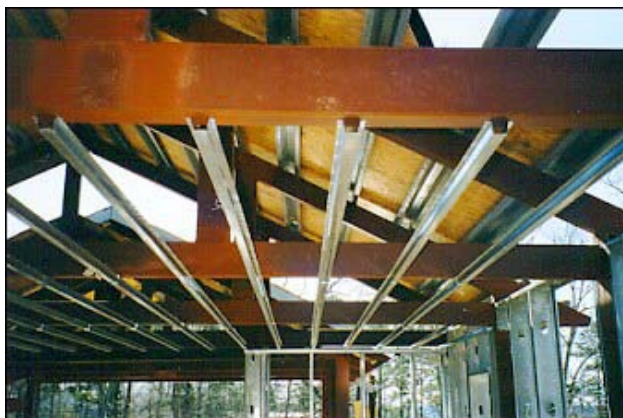
Figure 6.3.4.2-6

Mitigation examples with 1-1/2" hat channels at 16" on centers screwed in place with #12 self drilling screws and furring strips ready to receive gypsum board (Photo courtesy of Excalibur Steel). No special seismic details are required for this type of ceiling where the gypsum board is well secured directly to furring strips.

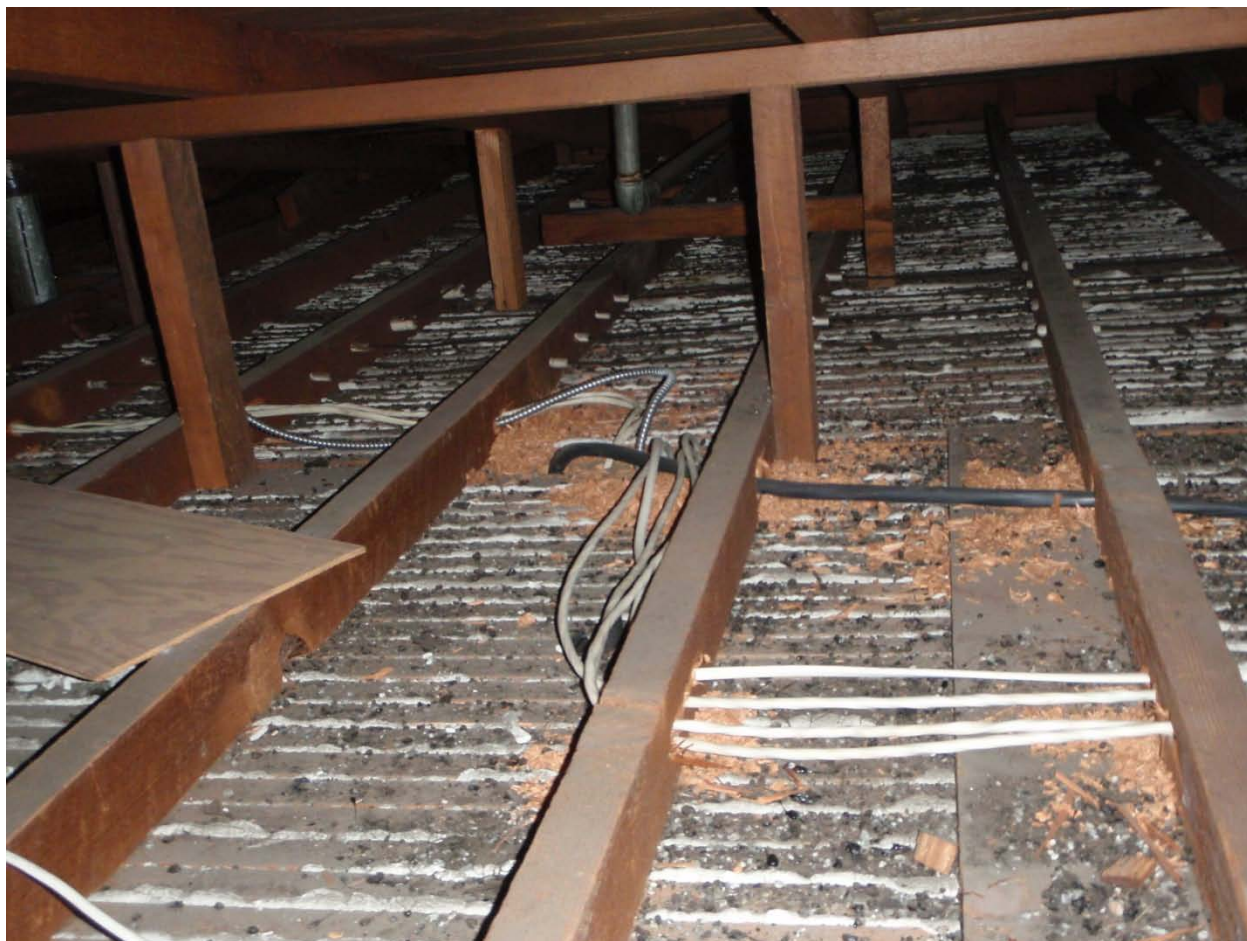
Figure 6.3.4.2-7 View of typical wood lath and plaster ceiling from the 1920's from above (Photo courtesy of Cynthia Perry, BFP Engineers). The wood lath is well nailed to the underside of the ceiling joists. This type of ceiling typically remains intact during an earthquake but may require crack repair and painting. Where the plaster has delaminated from the lath due to age or water leakage, wood strips could be installed from below as in Figure 6.3.4.2-8.

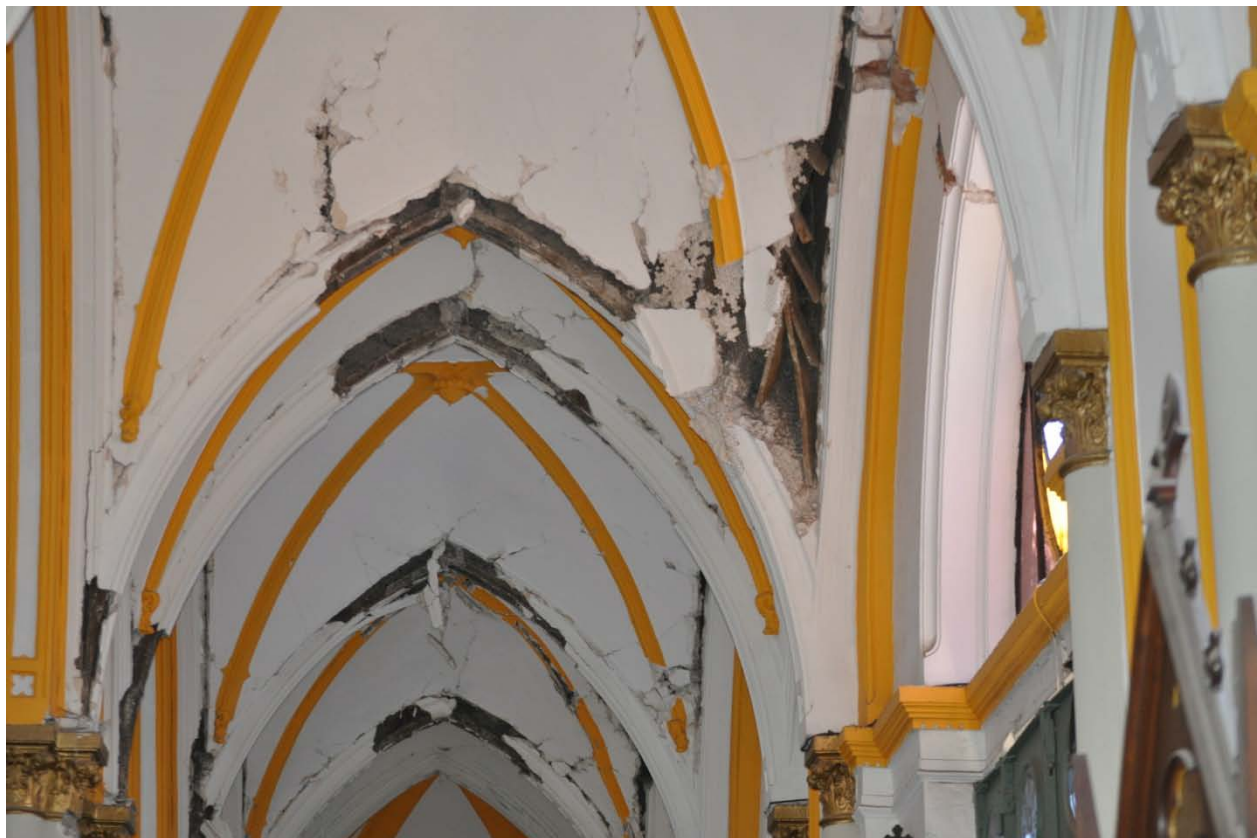
Figure 6.3.4.3-1 Damage to ornate wire lath and plaster ceiling in the 2010 magnitude-8.8 Chile Earthquake (Photo courtesy of Eduardo Fierro, BFP Engineers). Wire lath is attached to arches or to wood furring suspended from the roof framing.

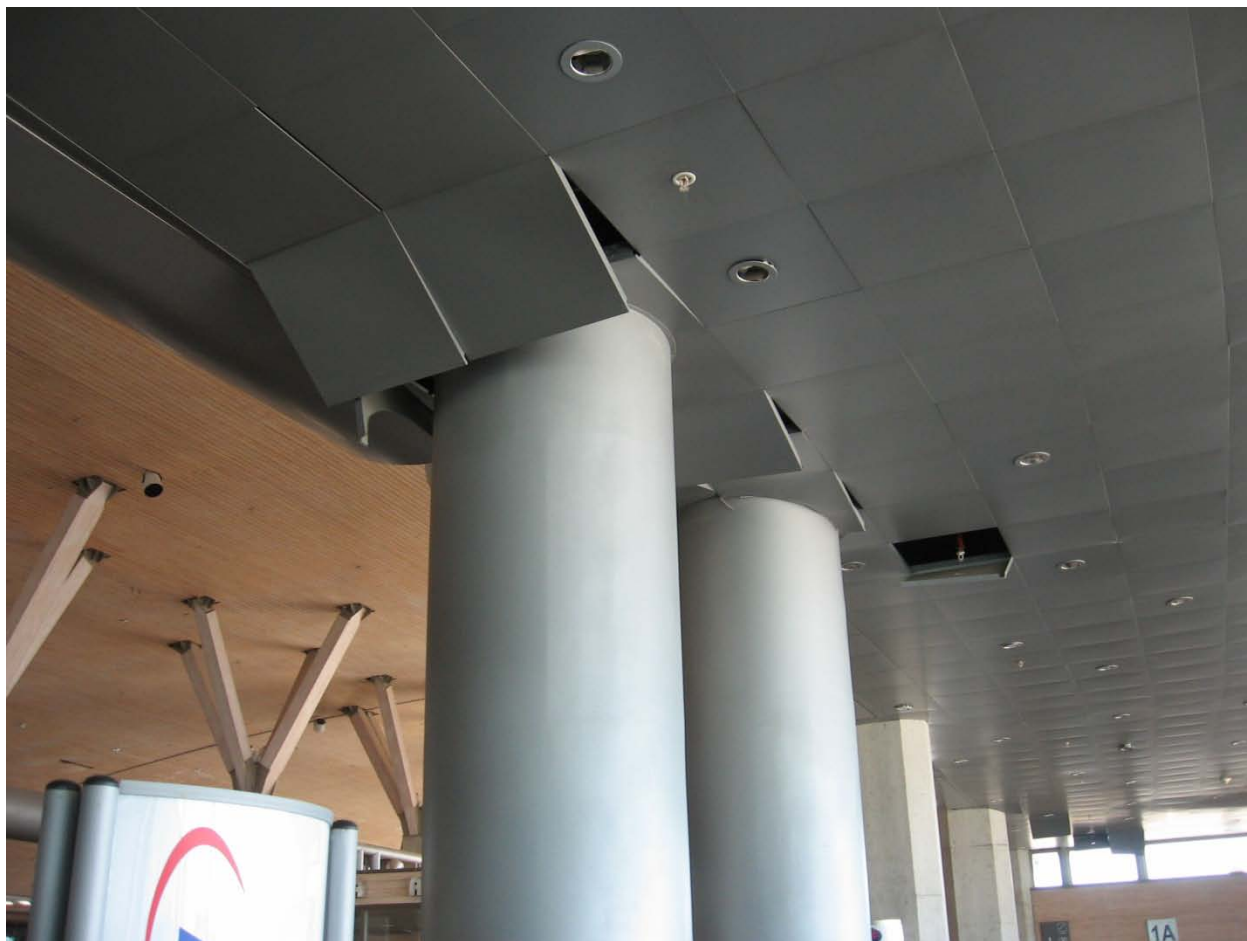
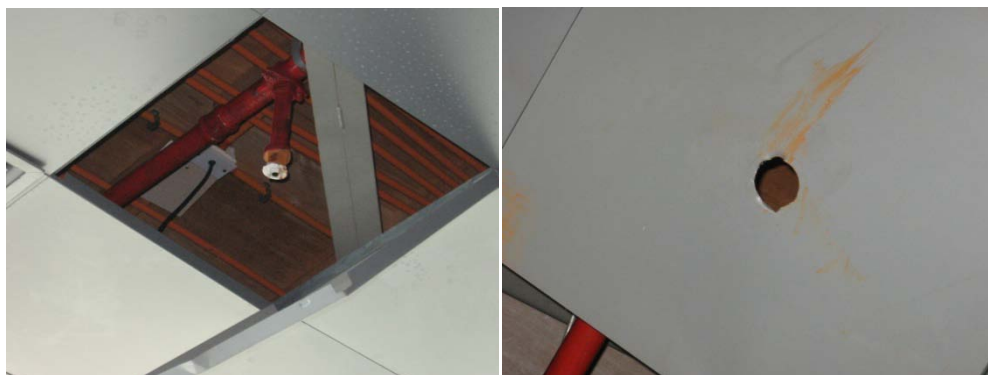
Figure 6.3.4.3-2 Damage to suspended metal panel ceiling system and fire sprinklers at Concepción airport, primarily at far end and around column obstructions in the 2010 Chile Earthquake (Photos courtesy of Rodrigo Retamales, Rubén Boroschek & Associates). The metal panel was strong enough to fail the sprinkler head shown at lower left.

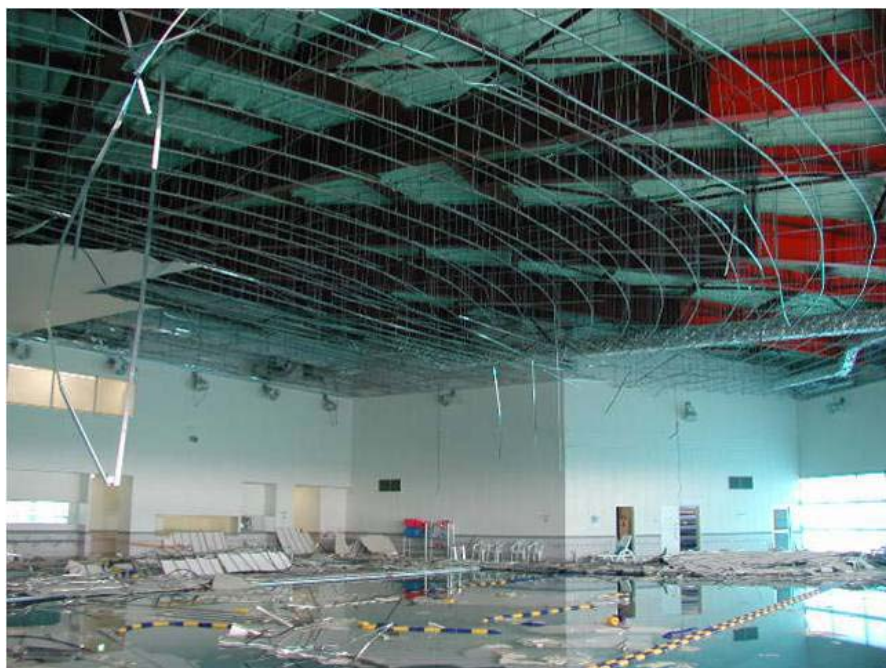
Figure 6.3.4.3-3a Complete collapse of a large suspended gypsum board ceiling over a swimming facility in Japan (Photo courtesy of Shojiro Motoyui, Tokyo Institute of Technology). This type of failure has been replicated on the E-defense shake table and occurs when the U-shaped clip holding the cross furring (M-bar) to the main runners (channel) opens into a V-shape and drops the furring grid. This type of failure is not common in the U.S.

- Mechanical connectors between the component parts of the ceiling assembly must be chosen carefully to avoid failures. Catastrophic failures of ceiling systems in Japan have been replicated during shake table testing because the U-shaped mechanical clip used to hang the cross furring from the main runner can open during an earthquake, dropping the cross furring and drywall as shown in Figures 6.3.4.3–3.

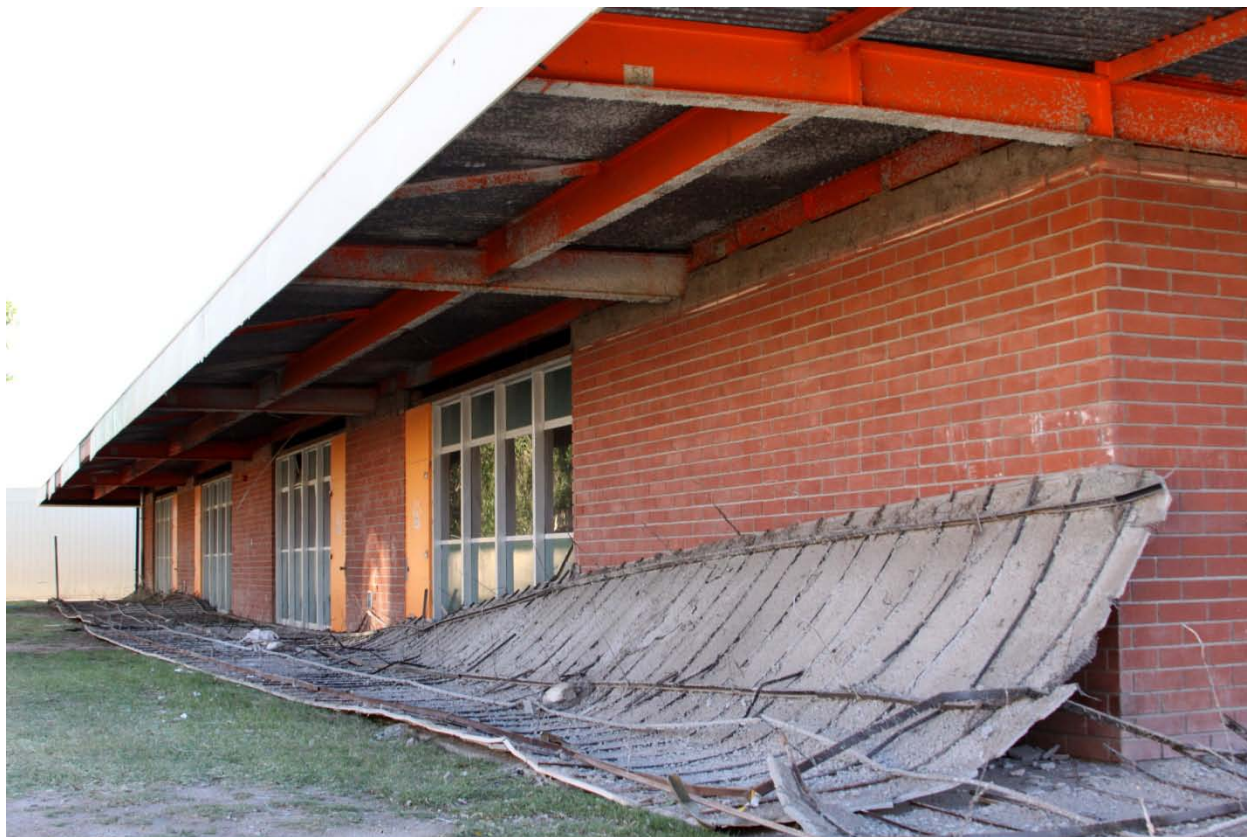
Figure 6.3.4.3-4 Collapse of exterior soffit at Jefferson Elementary School in Calexico in the 2010 Baja California Earthquake; approximately 1200 sq ft of soffit collapsed at this school built in the 1960's (Photo courtesy of Baja Earthquake Reconnaissance Team, Earthquake Engineering Research Institute (EERI), published in the EERI July 2010 Newsletter).

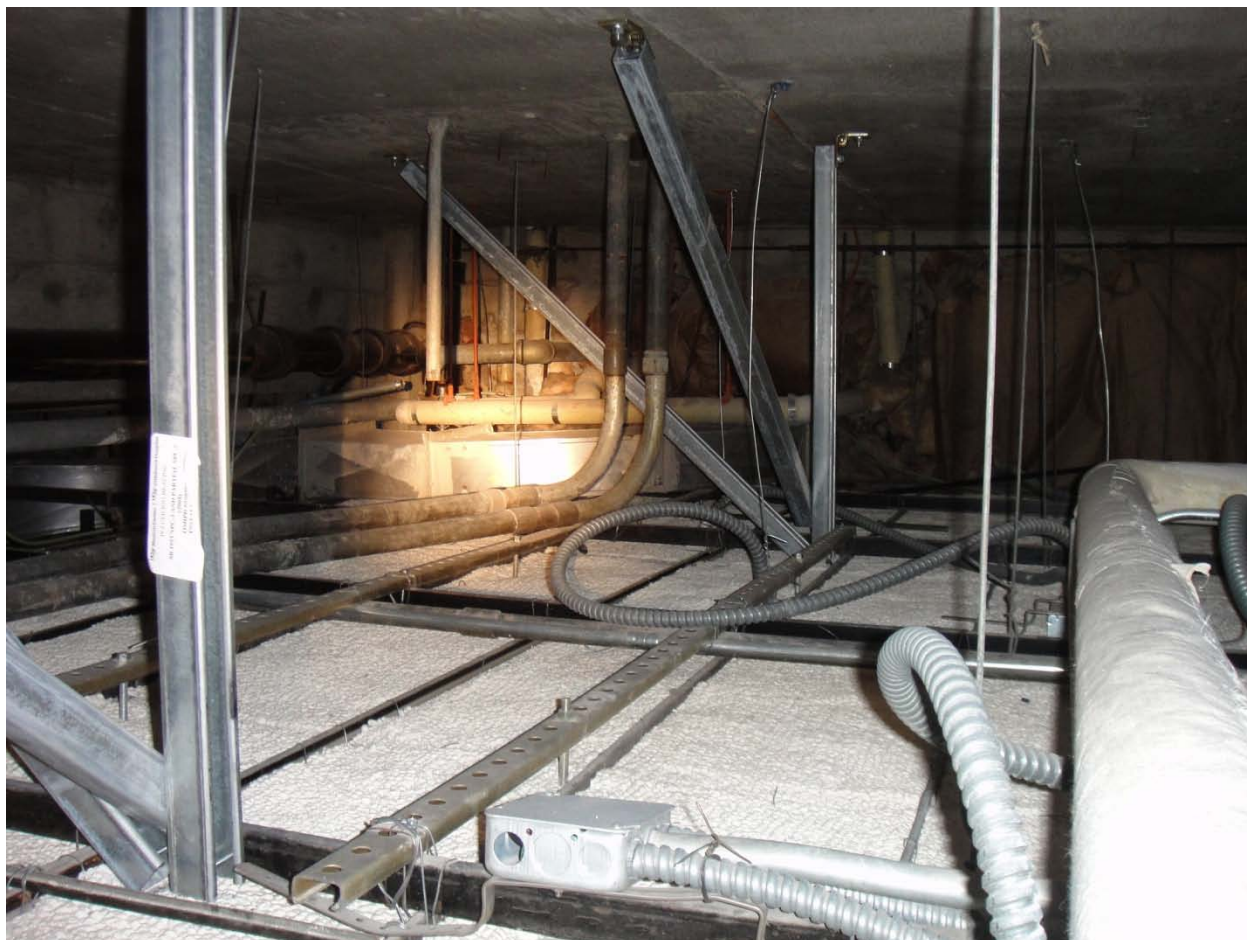
Figure 6.3.4.3-5 Details of suspended and braced gypsum board ceiling in California hospital. Rigid bracing is provided at 6 ft by 8 ft on centers. Note cross furring saddle tied to black channel (main runner) from below; supplementary framing for lights runs parallel to cross furring and saddle tied to main runner from above (Photo courtesy of Maryann Phipps, Estructure).
